**AL ESCANDDRONA SCHOOL
UNDER THE COMMANDER'S EMERGENCY RESPONSE PROGRAM
BAGHDAD, IRAQ**

SUSTAINMENT ASSESSMENT

**SIGIR PA-07-110
JANUARY 14, 2008**

SUBJECT: Report on the Rehabilitation of the Al Escanddrona School in the Karadah district of the city of Baghdad, Iraq (Report Number SIGIR PA-07-110)

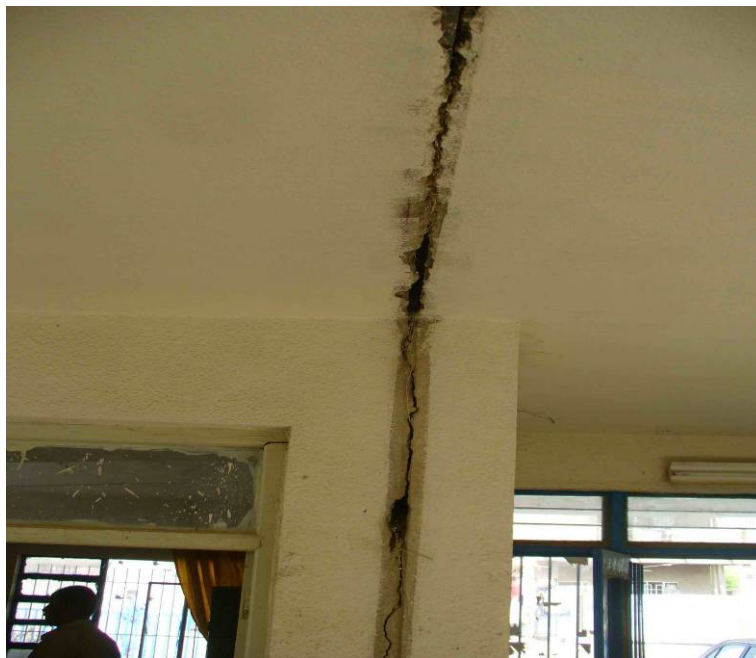
Before the rehabilitation project, the Al Escanddrona School was in major disrepair due to years of neglect. The school had cracks in the school room (Site Photo 1), loose electrical wiring (Site Photos 2 and 3), broken windows that posed safety hazards for the children (Site Photo 4), and an unusable lavatory.

Site Photo 1. Open expansion joint before renovation (Photo courtesy of USACE)

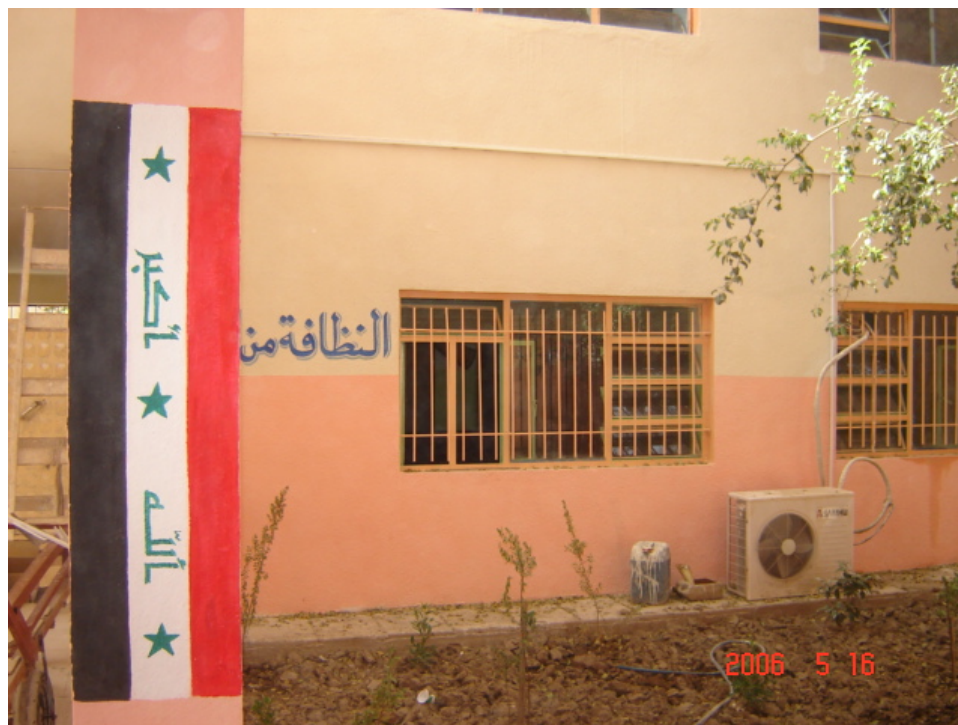
The contract called for general maintenance to be performed by the contractor on the building roof, walls, windows, doors, and exterior and interior painting. Site Photo 5 shows the school's exterior painting by the contractor.

Site Photo 5. Exterior painting after renovation (Photo courtesy of USACE)

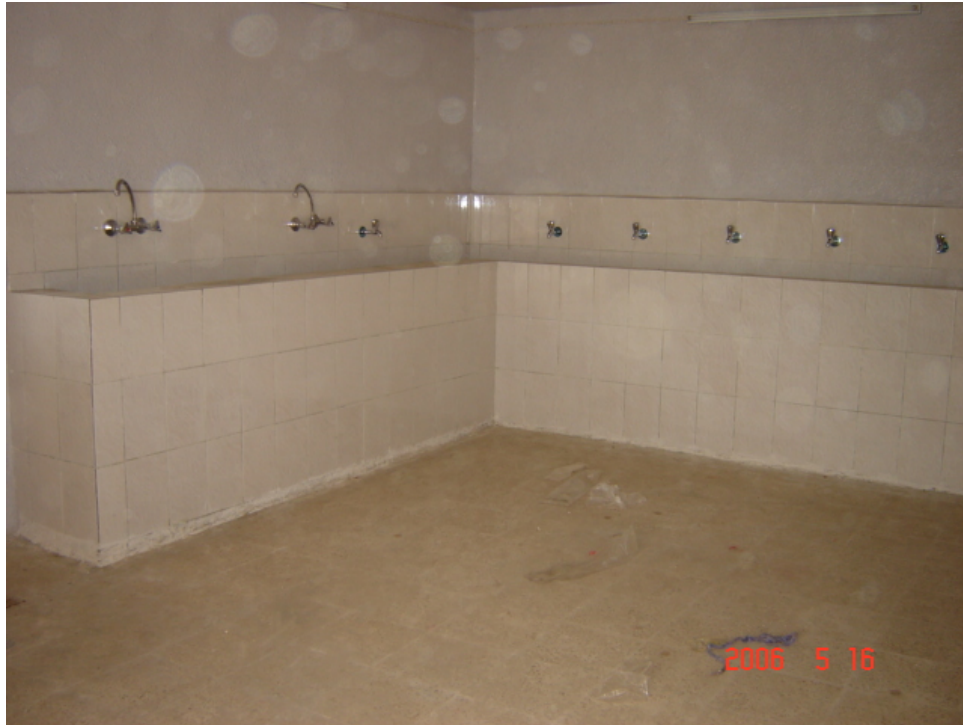
The contractor rehabilitated the lavatories, as required by the contract. Site Photo 6 shows the contractor's performance in tiling the lavatory and installing the sinks. The contractor installed new eastern-style toilets as well.

Site Photo 6. Sinks after renovation (Photo courtesy of USACE)

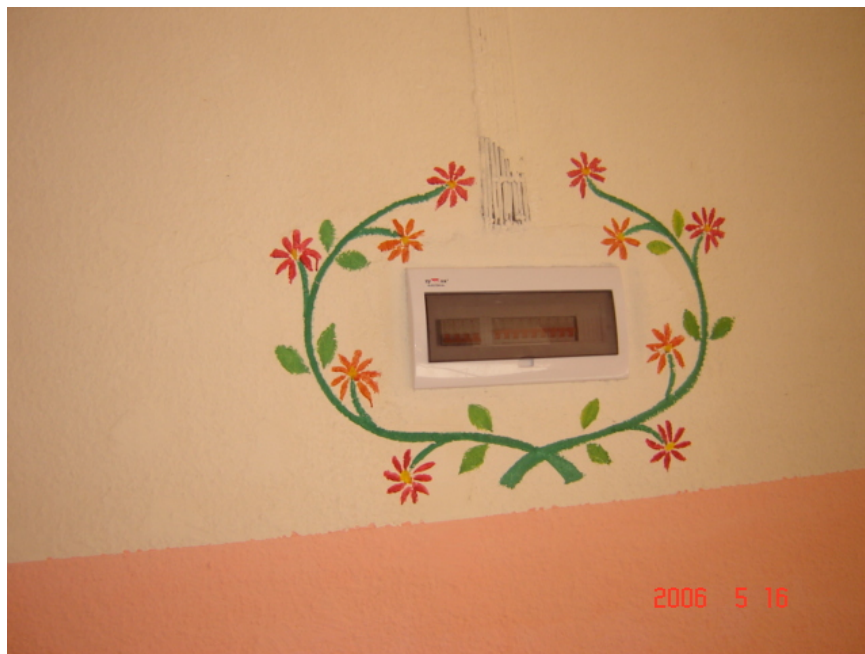
According to the contract, the contractor was to replace all electrical building network wiring. Site Photo 7 shows the electrical rewiring, the new electrical switch plates are shown in Site Photo 8, and the contractor-installed new air conditioning unit is shown in Site Photo 9.

Site Photo 7. Interior painting and electrical rewiring after renovation (Photo courtesy of USACE)

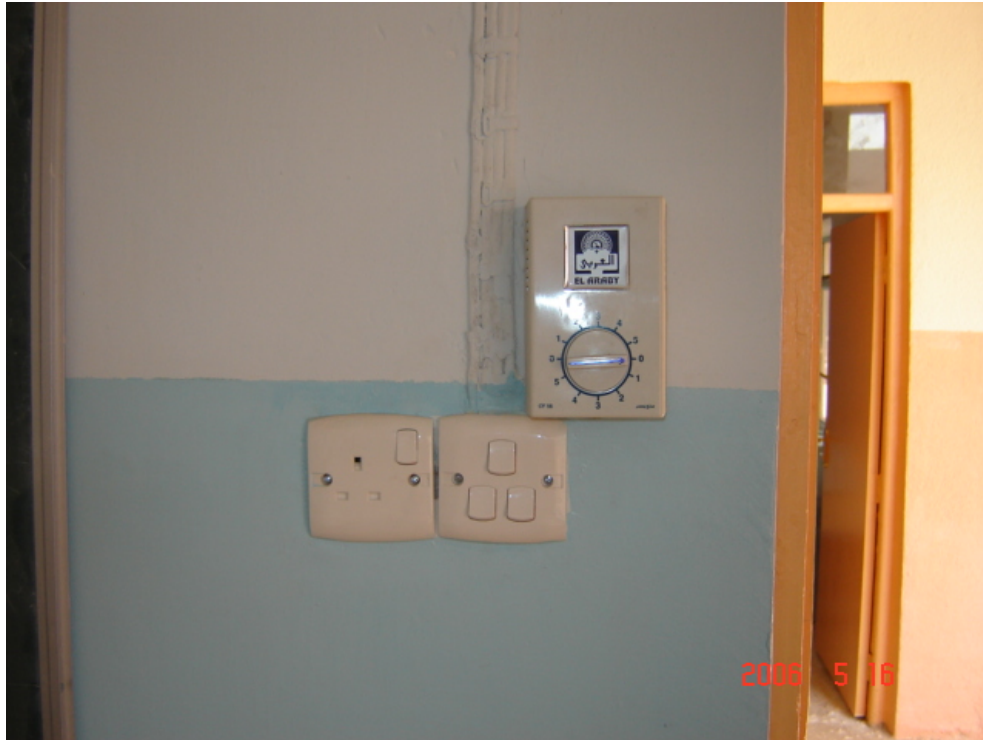
Site Photo 8. Correctly installed electrical switches and ceiling fan control after renovation (Photo courtesy of USACE)

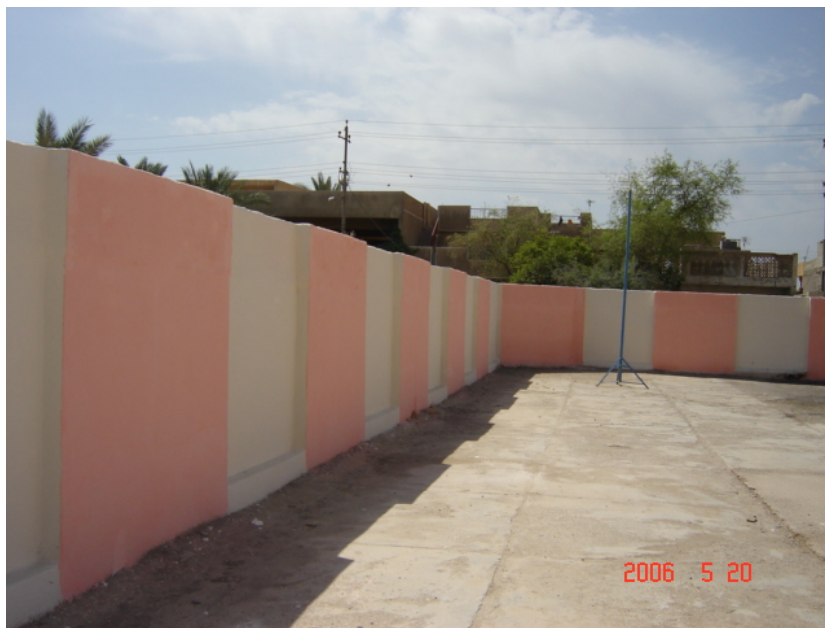
The contract stated that the contractor was to provide and install a security fence, and Site Photo 10 shows the fence/wall provided by the contractor as well as the painting for the fence/wall.

Site Photo 10. New masonry compound fence/wall (Photo courtesy of USACE)

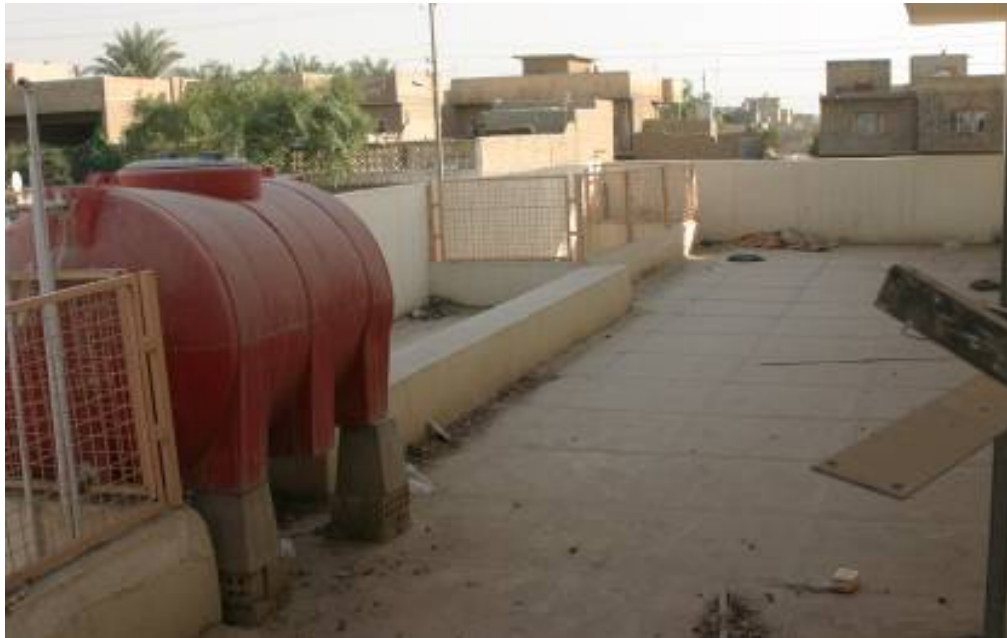
- general maintenance for the building roof, (Site Photo 11) walls, windows, doors, and painting on the exterior and interior (Site Photo 12)
- rehabilitated lavatory
- supply and installation of a new water plastic tank (Site Photo 11)
- replacement of all electrical building network wiring
- provision and installation of a 2.5 meter tall security fence (Site Photo 13)

Site Photo 11. Roof maintenance after occupancy and use (Photo courtesy of USACE)

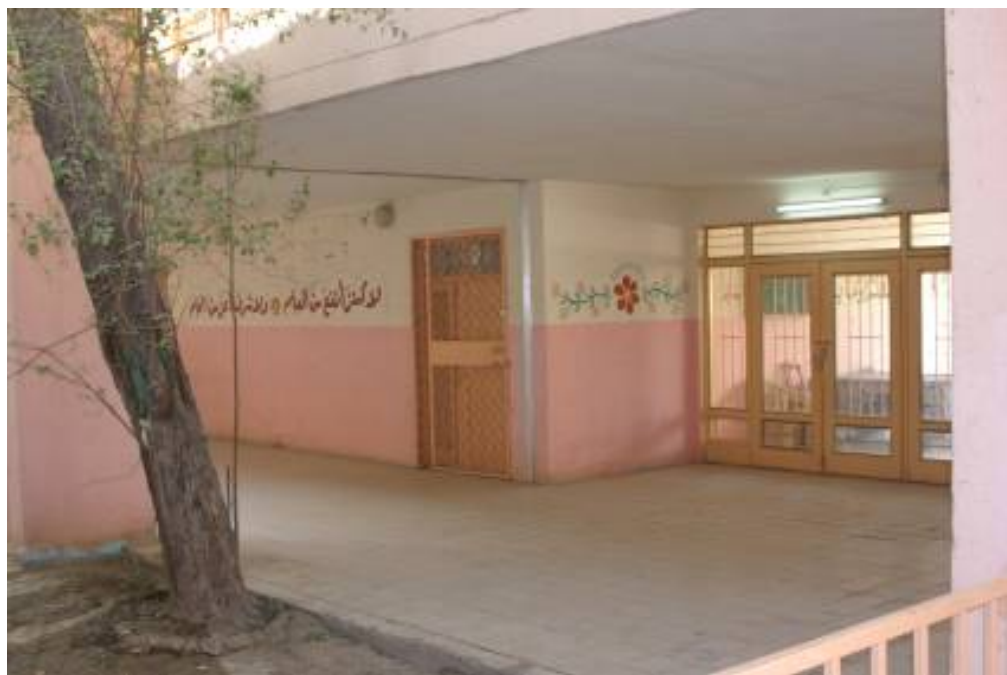
Site Photo 12. Interior painting after occupancy and use (Photo courtesy of USACE)

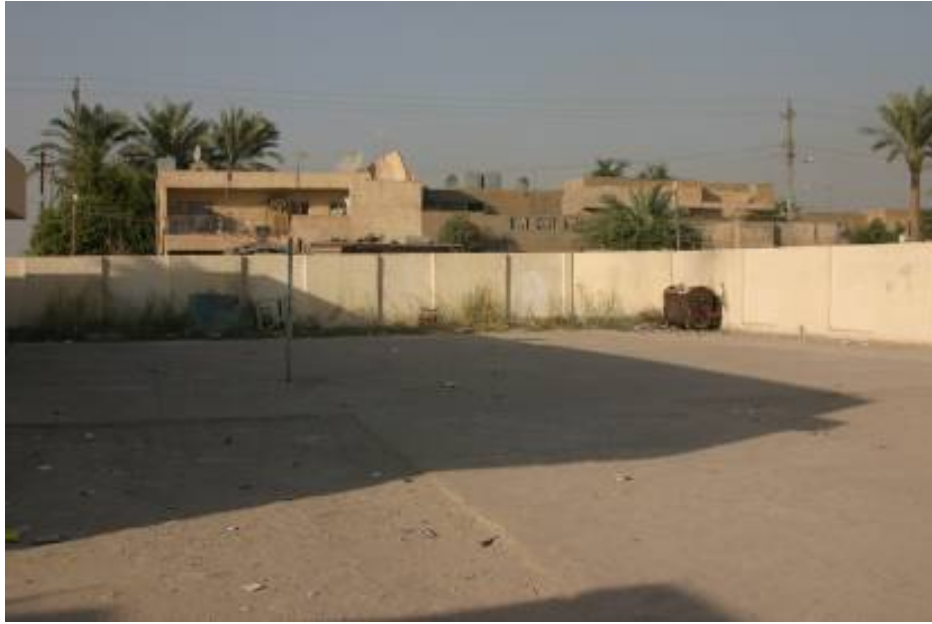
**Site Photo 13. School yard within compound wall after occupancy and use
(Photo courtesy of USACE)**
